Article

Material Behavior and Fatigue Assessment of Old Steel Bridges of the Spanish Conventional Rail Network

Citation: Presno Vélez, Á.; Bernardo Sánchez, A.; Bruna, O.A.; Abella, D.M.; de Prado, L.Á.; Fernández, M.M. Material Behavior and Fatigue Assessment of Old Steel Bridges of the Spanish Conventional Rail Network. *Materials* **2021**, *14*, 5275. <https://doi.org/10.3390/ma14185275>

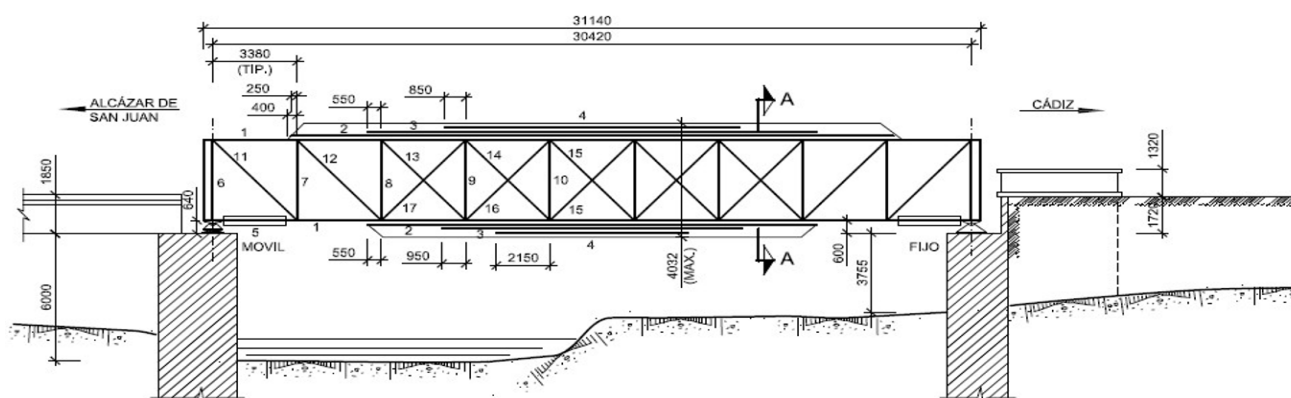
Figure 2. “Arroyo Corbones” elevation sketch (dimensions in mm).

The metal section that was the object of study corresponds to that of the left road, which is the one that receives the passage of exceptional transports and therefore a higher mechanical load. It is a single-span bridge with 30.42 m between support axes and 31.14 m of beam length, in the Pratt beam typology with nine squares with the five central squares arranged contradiagonal, according to the arrangement reflected in the following sketch (Figure 2).

The maximum depth of the structure is 4.03 m, approximately 3.6 m between the centers of gravity of the main chords, which translates into slenderness of approximately 1/8, typical of bridges built under “high load requirements”, one of the categories of the Instruction of 1925 [24]. The number of squares marks the separation of the joists, 3.38 m, very similar to the edge, which means that the diagonals of the lattice are approximately 45°. The main beams consist of upper and lower chords with a T-arrangement and addition of horizontal blades towards the light center areas, with a single 500 mm × 12 mm web and horizontal plates 400 mm wide and 10 or 11 mm thick.

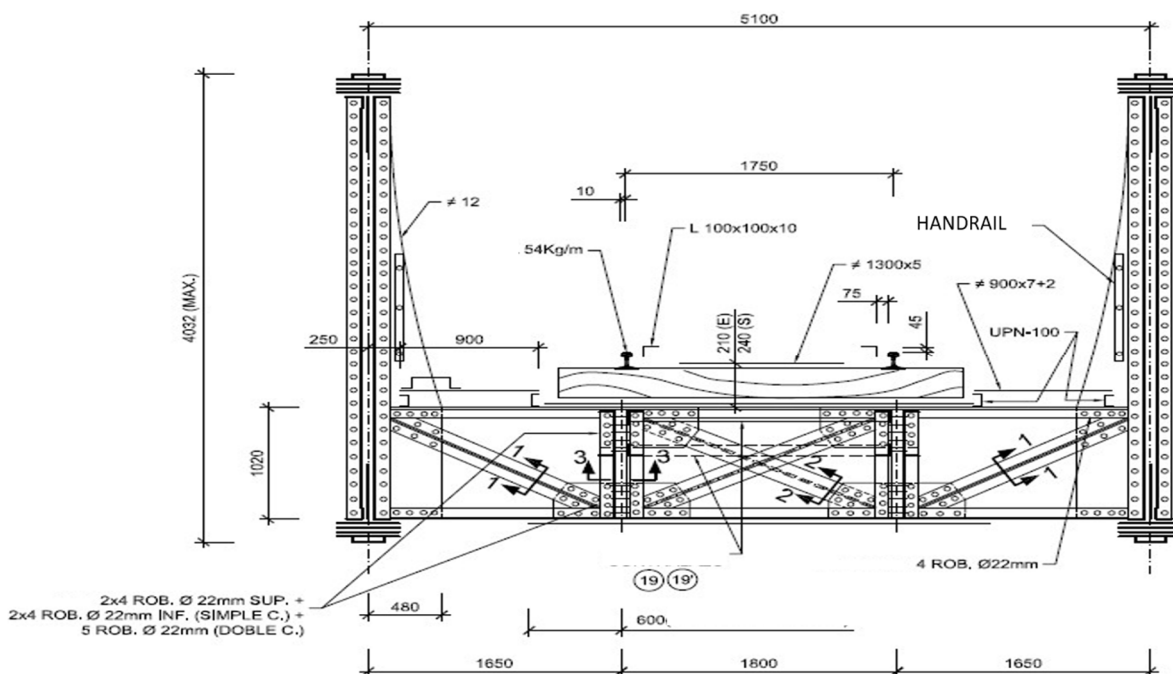
Figure 3. “Arroyo Corbones” transversal section sketch (dimensions in mm).

This original arrangement of the main chords has been modified by the successive addition of other pieces arranged to reinforce the original section. The uprights and diagonals are formed by the juxtaposition of angles, with more powerful sections as they approach the supports. The main beams have backlash diagonals in the five central squares, made up of the juxtaposition of two angles (Figure 3).

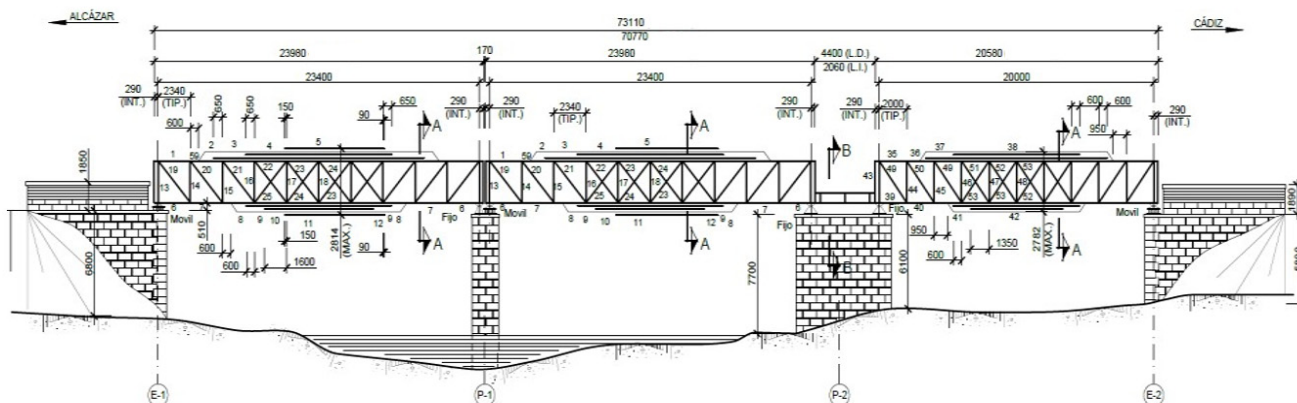
Figure 4. “Bembézar” elevation sketch (Dimensions in mm).

This bridge has the peculiarity that the distance between the end of the second span and the beginning of the third, in the abutment area is also saved by spars of different lengths given the skew of span in section two and the absence of skew in the span in section three, thereby achieving continuity of the metallic section (Figure 4).

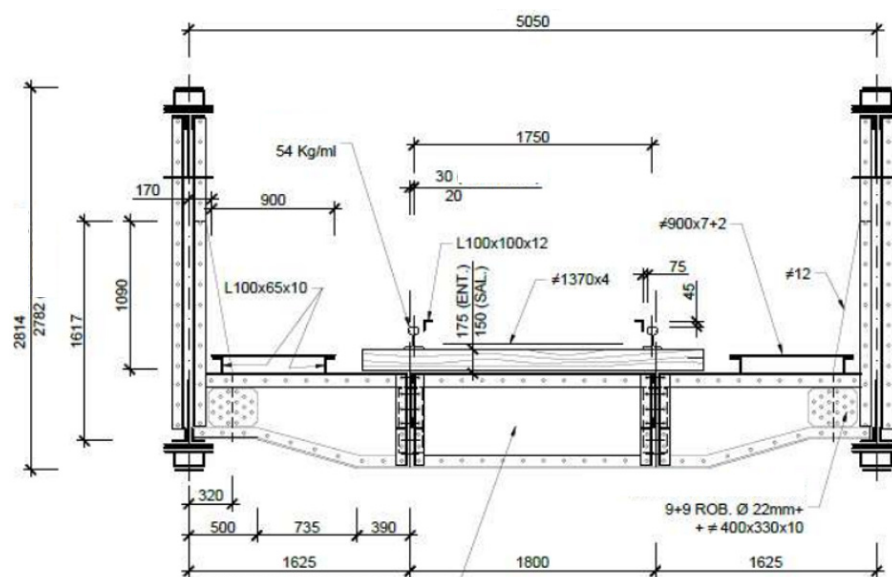
Figure 5. “Bembézar” transversal sketch (Dimensions in mm).

The typology of the metal sections is a Pratt beam with a lower deck (passing the train between the main beams). In the metal sections of 24 m in beam length (23.40 m between support axes), the maximum depth of the structure is 2.814 m, and in the 20 m. of light, the depth is 2.782 m (in reality it is 2.35 m between the centers of gravity of main heads).

In all of the cases, the metal sections consist of 10 squares, which marks the separation between joists, which is at a tenth of the span, that is, 2.34 m and 2.00 m (Figure 5).

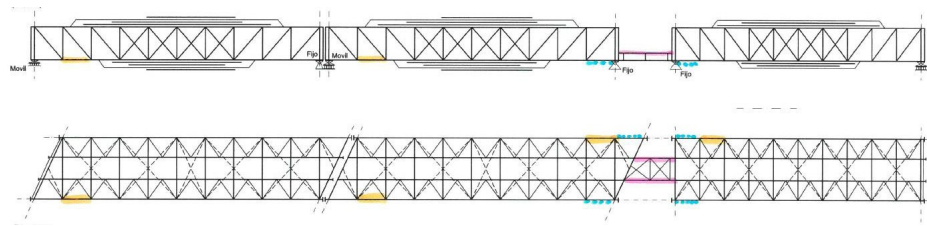
Figure 6. “Bembézar” sampling sketch. Yellow: bottom chord of the main beam, Blue: bottom chord of external beams on the 2nd pile, Pink: stringers on the 2nd pile.

minimize operations depending on the location. Figure 6 sketches the extraction zones for the sampling. Figure 7 shows some sample examples after extraction.

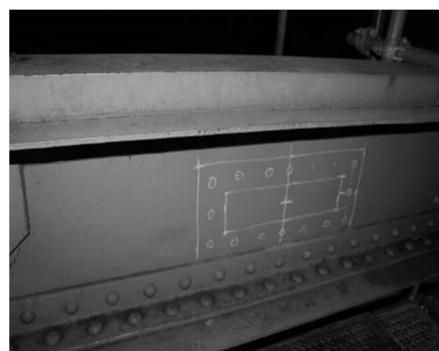
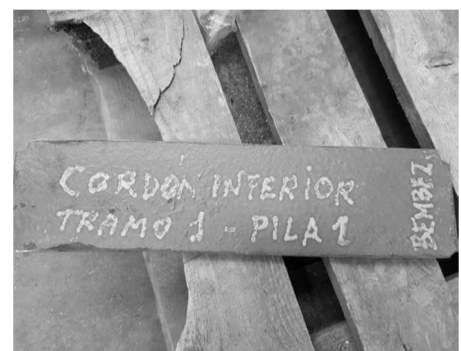
Figure 7. (a) Sample position example from the “Bembézar” bridge; (b) Sample example after extraction from the “Bembézar” bridge.

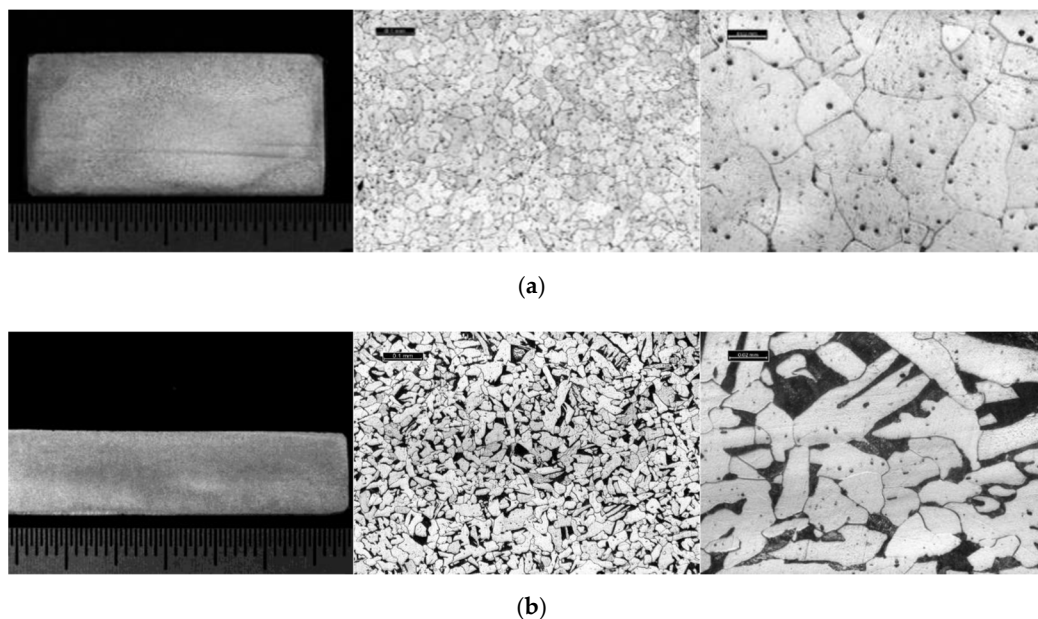
Figure 8. Macrographic and micrographic results for both studies. (a) From left to right: Macrographic, micrographic 100×, micrographic 500× “Bembézar” Stringer sample; (b) From left to right: Macrographic, micrographic 100×, micrographic 500× “Corbones” Stringer sample.

The microstructure is mainly formed by grains of ferrite, a characteristic structure of mild steel with very low carbon content. Small areas of the pearlitic matrix and traces of tertiary cementite can be seen in the grain joints. Again, a considerable number of non-metallic inclusions appear derived from the chemical reaction of the impurities present in the chemical composition of the material, such as manganese sulphides, oxides or silicates. No macro segregations or macroscopic defects such as sheet separation or porosity were observed. Figure 8 shows some representative examples of macrographic and micrographic (100–500×) examination.

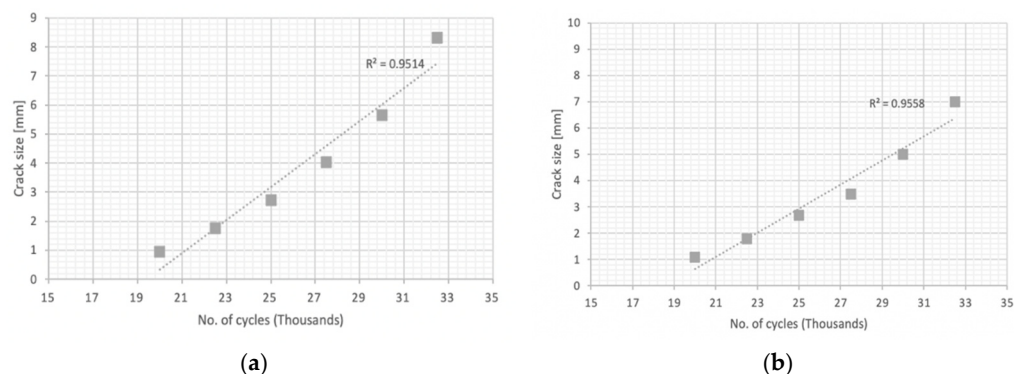
Figure 9. No. of cycles: crack size (a) Corbones Stringers; (b) Corbones Main Chords.

In the first place, fracture mechanics tests were carried out to determine the constant “m” that governs the speed of propagation of the crack according to the Paris’ law, by means of a test on a pre-cracked sample supported at two points with a center load. Figures 9 and 10 plot the no. of cycles vs. the crack size for pre-cracked SE(B) samples. Figures 11 and 12 show the relation between crack growth speed and the intensity factor. It is important to highlight that phase two was carried out only on samples from the chords and stringers of “Bembézar” and “Corbones”. Figure 13 shows crack growth sequence examples.

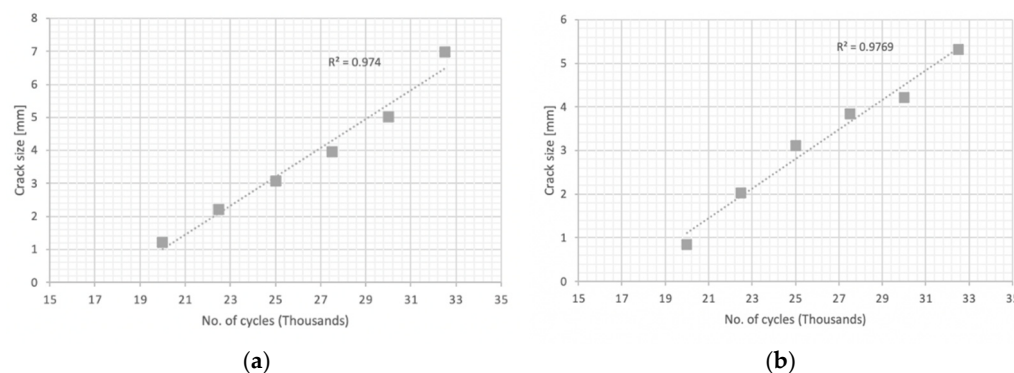
Figure 10. No. of cycles: crack size. (a) Bembézar Stringers; (b) Bembézar Main Chords.

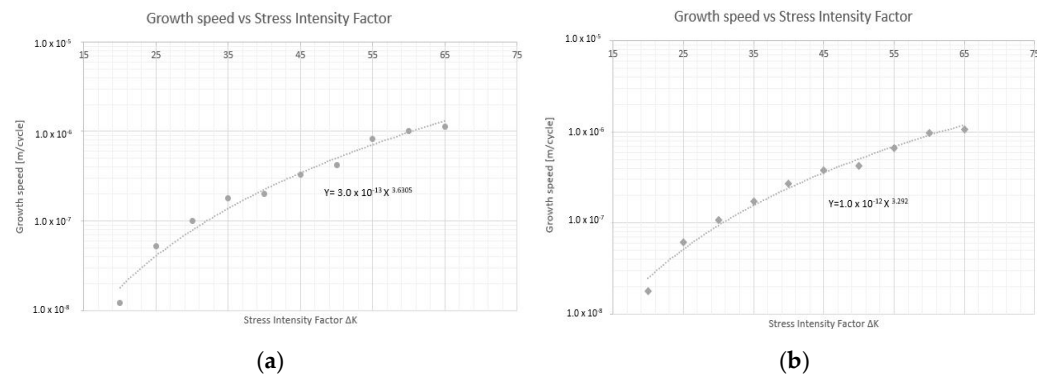
Figure 11. Growth speed vs. intensity factor. (a) Corbones Stringers, $m = 3.63$; $C = 3 \times 10^{-13}$; (b) Corbones Main Chords, $m = 3.29$; $C = 1 \times 10^{-12}$.

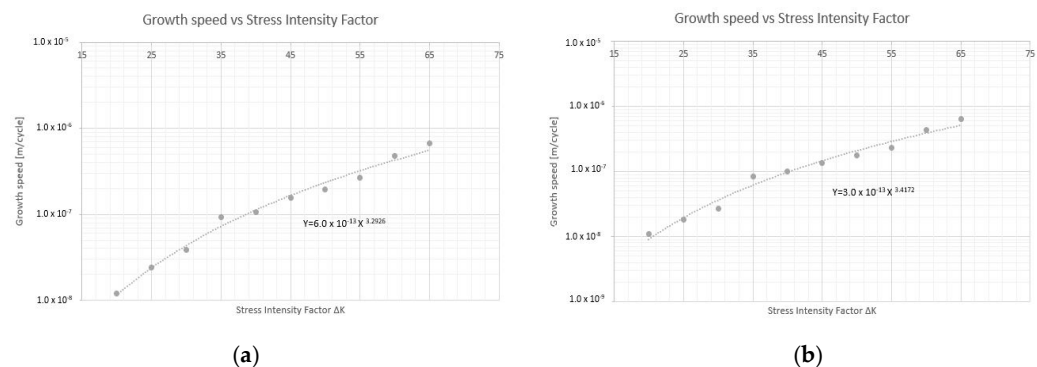
Figure 12. Growth speed vs. intensity factor. (a) Bembézar Stringers, $m = 3.29$; $C = 6 \times 10^{-13}$. (b) Bembézar Main Chords, $m = 3.41$; $C = 3 \times 10^{-13}$.

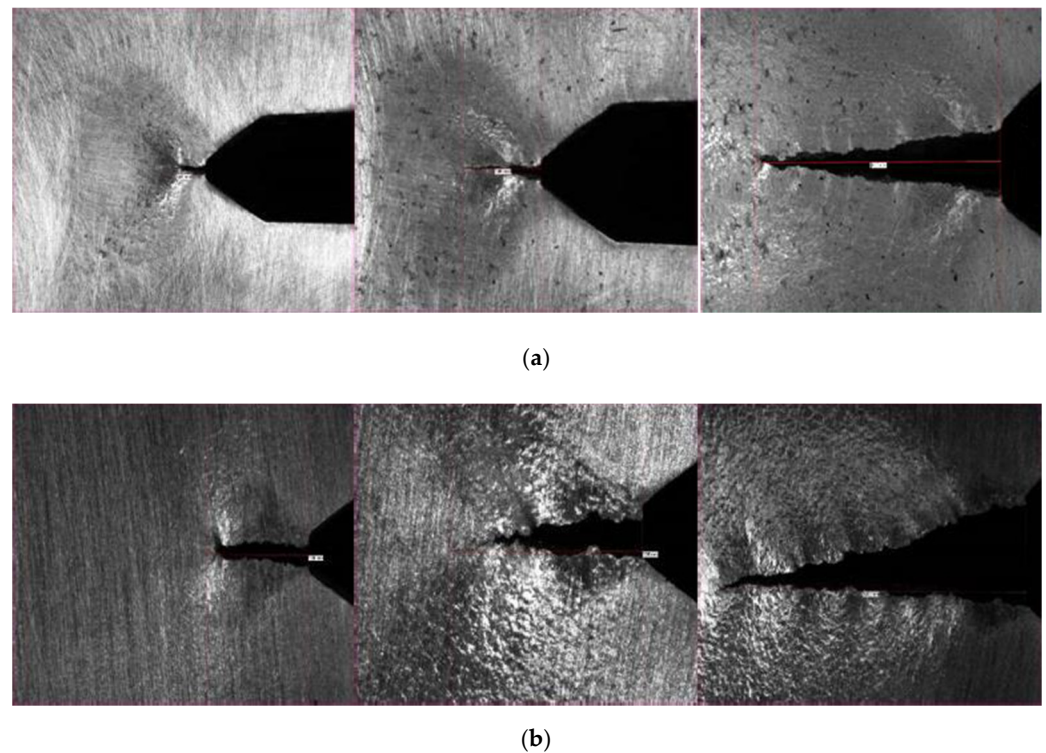
Figure 13. Crack growth sequence example (a) Bombézar Stringers; (b) Bombézar Main Chords. The width of each image corresponds to 5 mm.

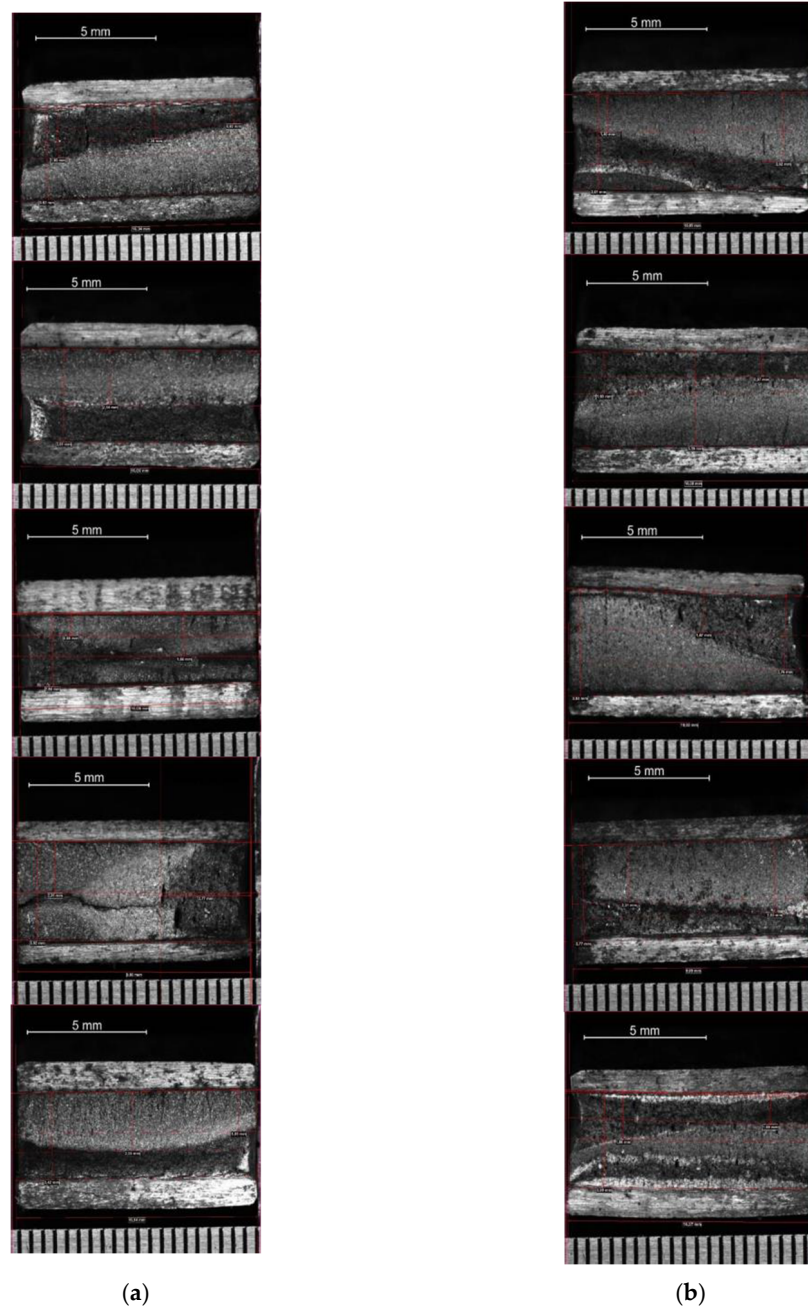
Figure 14. Sample fractography (a) Corbones Stringers; (b) Corbones Main Chords.

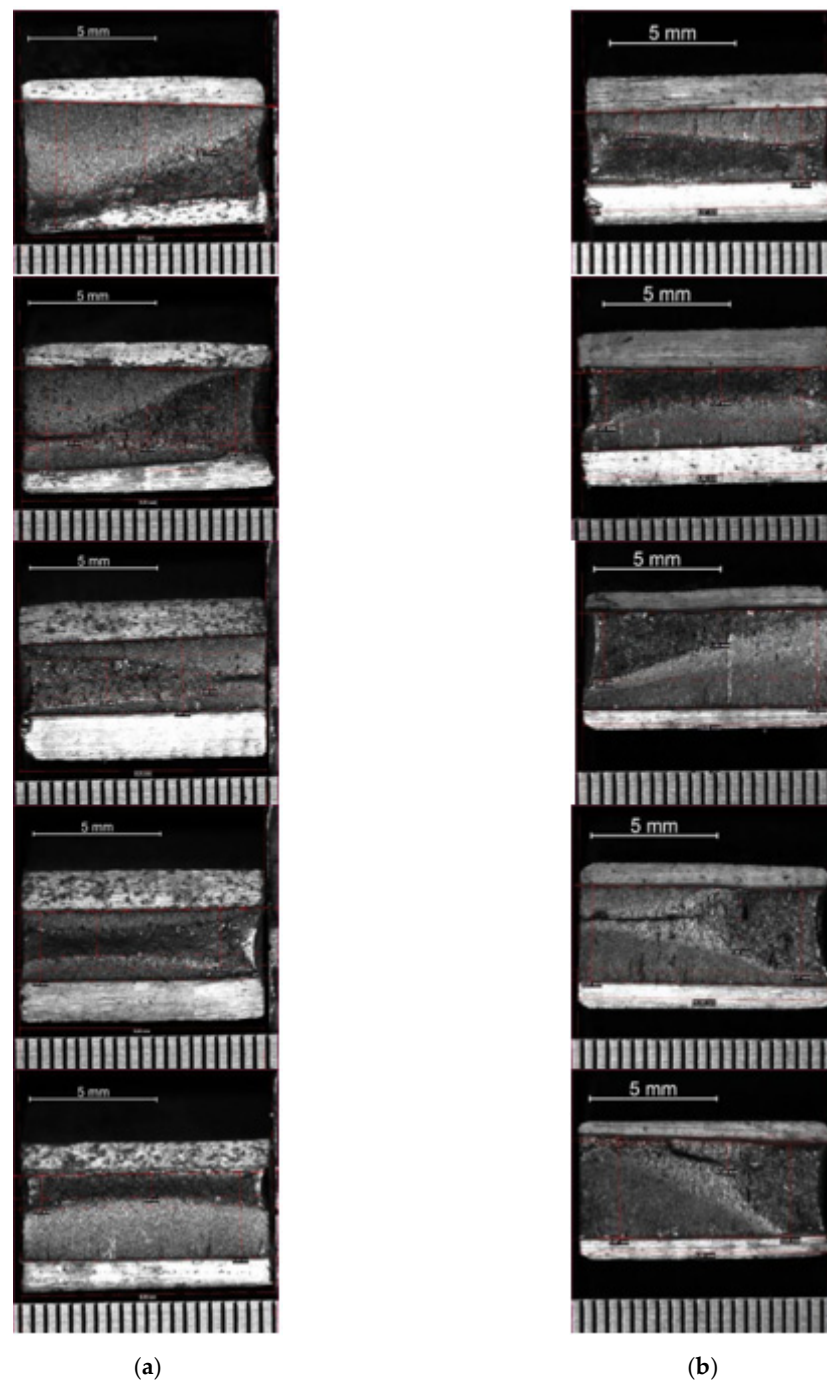
Figure 15. Sample fractography. (a) Bembézar Stringers; (b) Bembézar Main Chords.

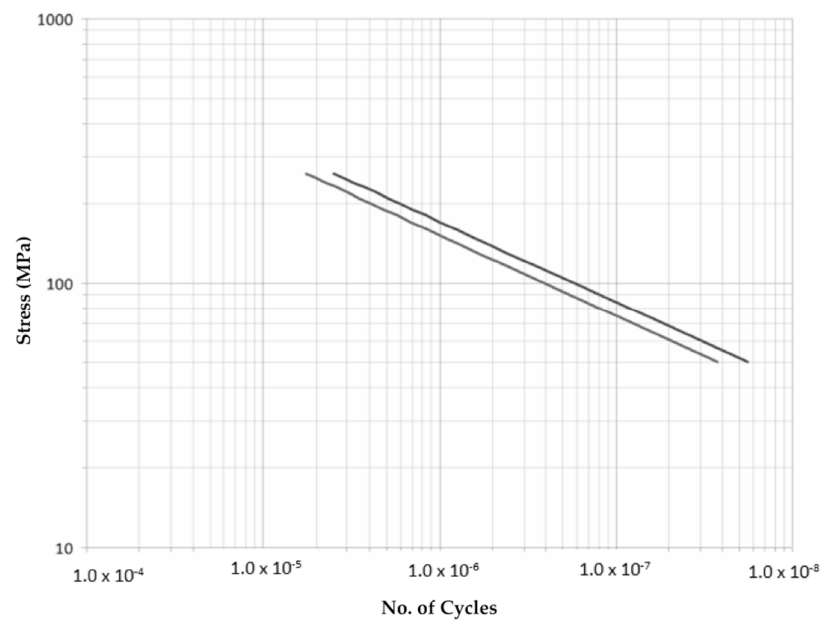
Figure 16. Corbones S (MPa)-N approximation. Dark: Strings, Light: Chords.

The results obtained allow an extrapolation regarding the number of cycles reissued at tensions other than 200 MPa according to the theoretical behavior collected by Paris' law. We opted for such a simple model due to its ubiquity and easy correlation. The results are displayed in Figures 16 and 17.

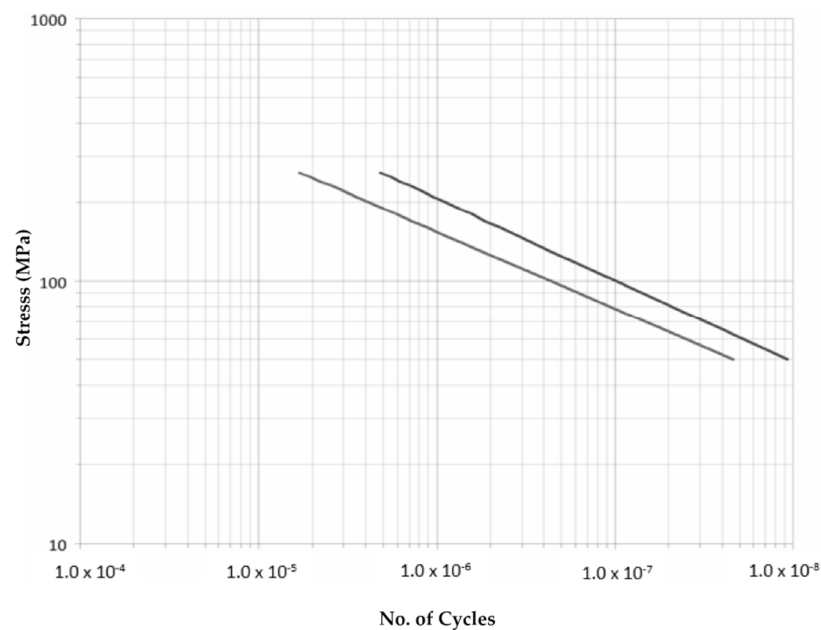
Figure 17. Bembézar S (MPa)-N approximation. Dark: Strings, Light: Chords.

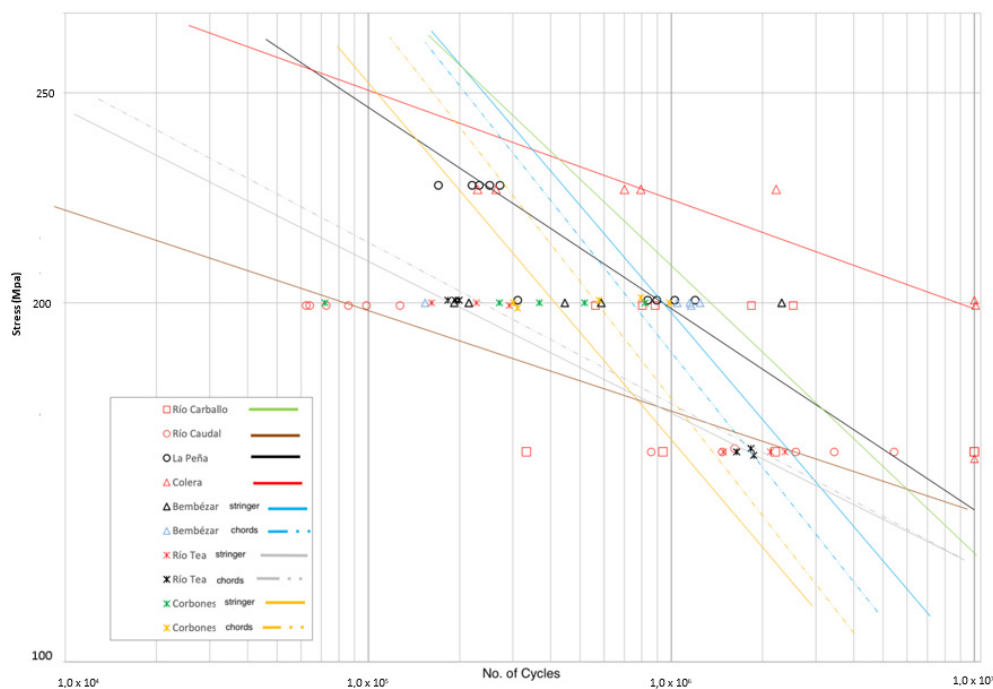
Figure 18. Summary of results. Stress (MPa) vs. No. of cycles for double-notched uniaxial fatigue tests (frequency: 10 Hz, R: 0.1).

Finally, the evolution of the number of cycles resisted for the amplitude of loads is shown in Figure 18, where all the values obtained in the tests are shown together. It should be noted that in the case of the “Corbones” and “Bembézar” bridges, the values given by the Paris’ law were represented based on the results obtained on a 200 MPa amplitude tension test, since no tests were performed on other loads.

The slope of the lines reflects an aspect of great relevance, such as the influence that a variation in the applied load has on the number of cycles resisted.

In this sense, the results obtained in all cases offered more stretched lines than those represented for the Corbones and Bembézar bridges given by Paris' Law, for which values of the k coefficient between 3.19 and 3.4 were found. The results obtained in other bridges led to significantly higher values of the k coefficient, 4.57 in the metallic material of the "La Peña" bridge but 7.7 in the main chord material in "Río Tea" and up to 8.6 in the "Colera" bridge. However, the material of this bridge shows great behavior against fatigue (right and upper part of the graph).

The graph above reflects that, at least in terms of the results found in the tests, it is not uncommon to find values of the coefficient "m" higher than the theoretical values determined by Paris' law and reflected in the literature as normal values between three and five, which results in a more rapid loss of resistance to fatigue with the increase of load amplitude. This can be explained by the presence of impurities or defects in the material.
